PORT ARTHUR LNG LIQUEFACTION PROJECT

DRAFT RESOURCE REPORT NO. 2 WATER USE AND QUALITY

Port Arthur LNG, LLC 2925 Briarpark Dr., Suite 900 Houston, TX 77042

June 2015

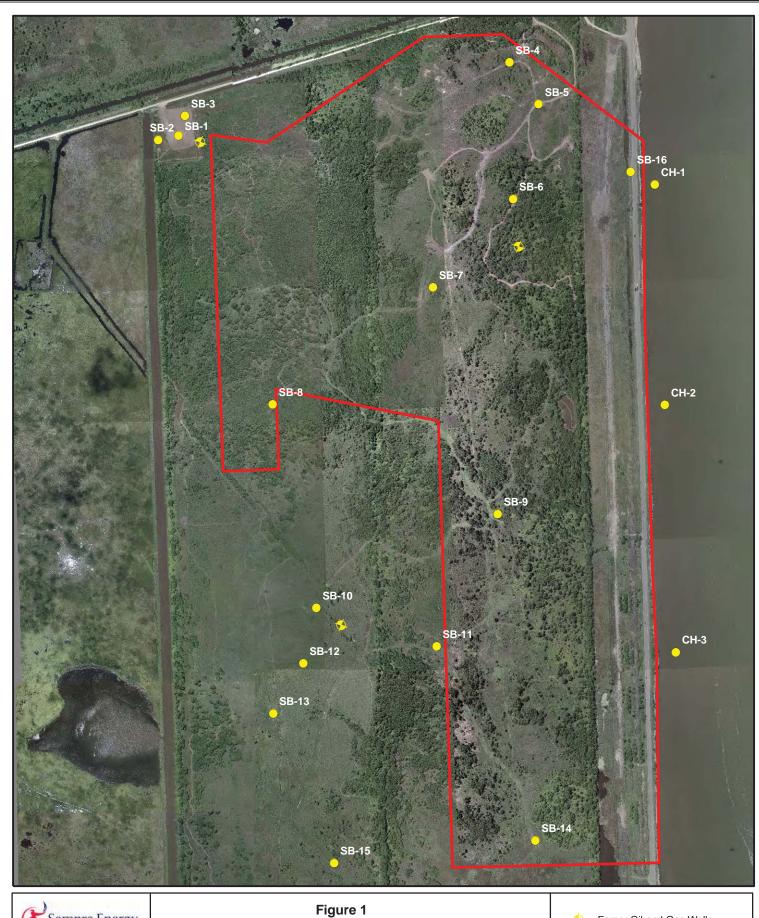
Figure 1
Soil Sample Locations for the Port Arthur LNG Project

The study included the collection of 15 soil borings and three sediment samples from the Port Arthur Ship Canal at the Project site. Sample locations were spread across the site, as shown in Figure 1.

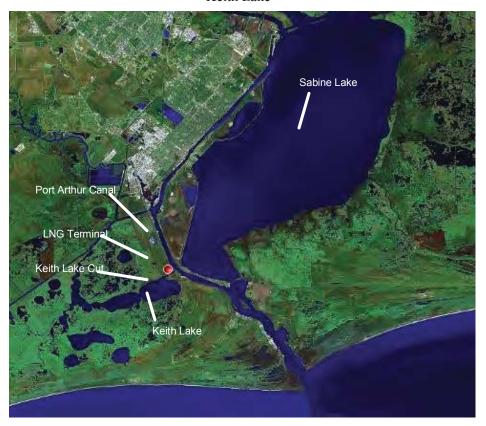
Figure 3 Satellite image of study area (Source: Terraserver)

The study incorporates four distinct areas as shown in Figure 3:

- Sabine Lake
- The Port Arthur Canal, forming part of the Sabine-Neches Waterway (SNWW)
- The Keith Lake Cut (or Keith Lake Fish Passage)
- Keith Lake

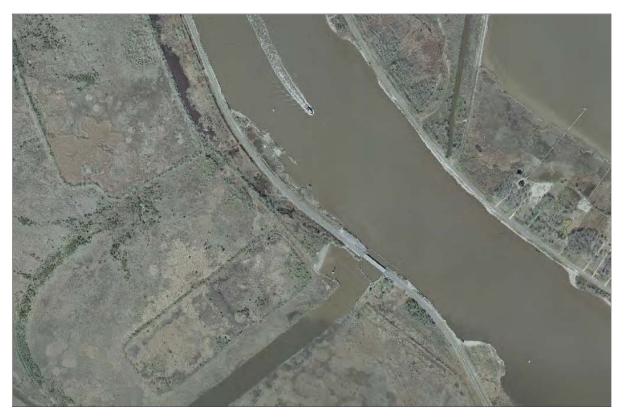
Figure 5 Air photo of Port Arthur Canal and Keith Lake Cut

Figure 5 is a color air photo of the Keith Lake Cut showing a turbid plume of sediment entering the cut from the Port Arthur Canal during flood tide conditions – this illustrates the high background turbidity levels presently brought in to Keith Lake via the Keith Lake Cut.

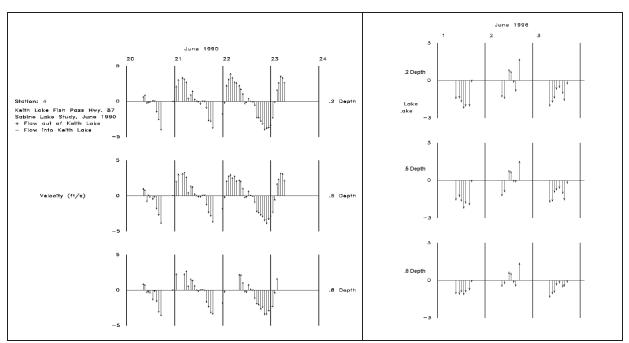
Figure 9 Velocity measurements from Keith Lake Cut, (TWDB 1900 and 1996)

Flow velocities in the Keith Lake Cut measured during a 1996 field campaign conducted by the Texas Water Development Board (TWB, 1996) are shown in Figure 9. Here it can be seen that for the 1990 data the mean velocity is approximately 0 while peak flood and ebb flows being roughly 1 m/sec in both directions. The 1996 data is more sparse and indicates peak flow speeds of about 0.8 m/sec and a net velocity toward the east.

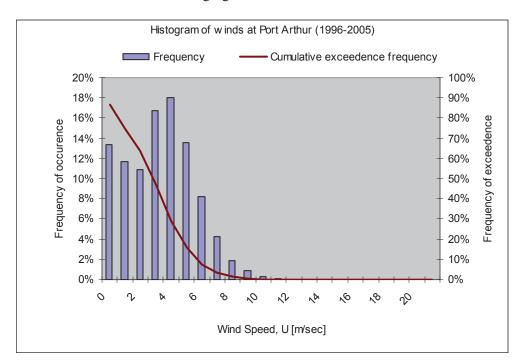
Wind effects were considered in terms of the wind-driven circulation of water in Sabine Lake as well as the effects of wind-generated waves. A statistical analysis of wind data from Port Arthur has been conducted. The resulting wind speed histogram is shown in the following figure.

Figure 10 Winds in the area range average 3.35 m/sec with 10% exceedance level of 6m/sec and 1% exceedence level of 9m/sec

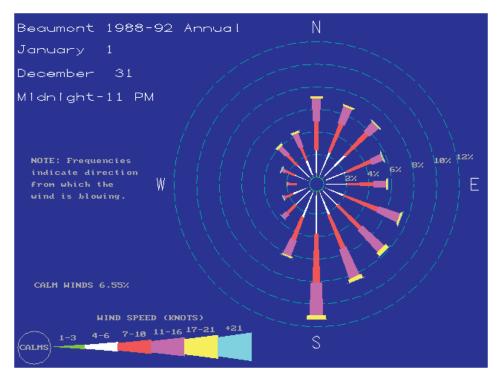
Figure 11 Wind rose for Port Arthur, Tx (www.tceq.state.tx.us/assets/public/compliance/monops/air/windroses)

The directional distribution of wind speeds at Port Arthur is summarized in the wind rose presented in Figure 11.

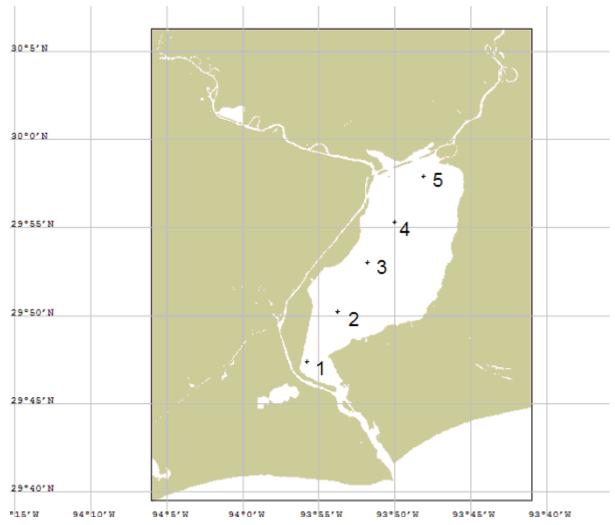
Figure 12 Five analysis stations along the Sabine Lake pipeline

Fetches vary with location in the lake and with wind direction. Nominally, fetches vary from 3 to 12 km. There is a 7 km fetch for winds coming across Sabine Lake from the SE. A matrix of wave conditions has been developed using the SMB-shallow water wave hindcasting technique for each of the 4 quartile wind speeds using a 8-point compass. Table 1 provides a breakdown of the frequency of occurrence of the quartile windspeeds by direction for each of 5 stations distributed along the Sabine Lake pipeline route. Figure 12 shows the locations of the 5 stations.

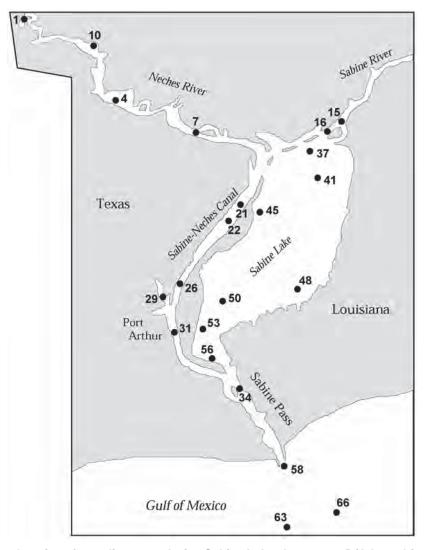
Figure 13 Station locations for sediment analysis: Sabine Lake, August 1995 (Adapted from Long, 1999)

Inc., 1997) as part of a larger survey of potential ecotoxicological effects in Sabine Lake sediments (Long, 1999). The survey encompassed an area of approximately 246 km and included sediment texture analysis of 22 samples from Sabine Lake, the Neches and Sabine Rivers, the Intracoastal Waterway, and Sabine Pass – see Figure 13).

Sediments in Sabine Lake are typical of estuaries in the northwestern Gulf, with variable amounts of sand, silt, and clay. As shown in Table 3, sediment composition at the 22 stations varied considerably, from 96.4% sand at station 1 to 66% clay at station 66; however, sediments at all stations except 1, 22, 37, 45, and 56 were dominated by the silt/clay fraction, mostly classified as silty clay or clay (Barry A. Vittor & Associates, Inc., 1997). Sediments at most stations within the lake tended to have greater sand percentages than stations in the rivers and the Sabine-Neches Canal. The total organic carbon (TOC) fraction was uniformly low and ranged from 0.38% at Station 50 to 3.88% at Station 1.

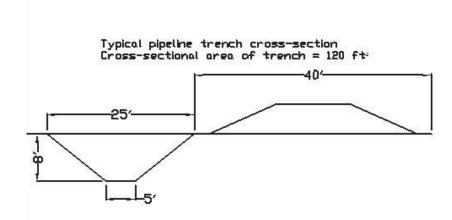
Figure 15 Pipeline trench geometry

The following table summarizes the total volume of material to be excavated and re-placed for the various pipeline trenching operations. Volumes are expressed in cubic metres of material as well as estimated daily rates.

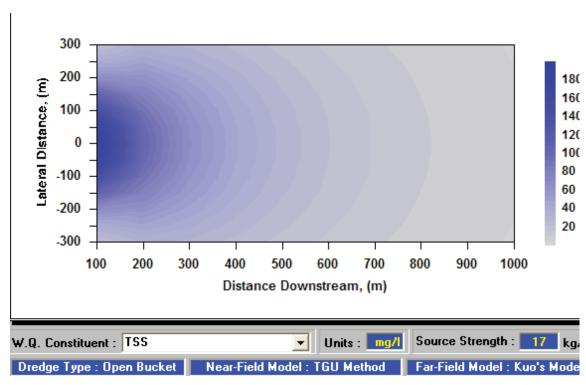
Figure 16 Dredge plume for Sabine Lake (0.1m/sec current, w=0.5mm/sec) using backhoe excavator

Turbidity generation rates for open backhoe operations are estimated as a TGU of 54 kg/m³. For the production rates at Sabine Lake this equates to a suspended sediment source rate of 17 kg/sec. The following figure shows the predicted plume concentrations from the USACE ADDAMS/DREDGE program for these conditions.

Considering that 24 mg/L is the Louisiana TSS threshold and that 40mg/L is the mean ambient TSS level in the Port Arthur Canal, it can be seen from the foregoing figures that the critical plume area from the Sabine Lake dredging can be expected to be of the order of 500 m wide and about between 0.5 and 1 km long (varying significantly with actual dredging practices, with sediment characteristics and local currents).

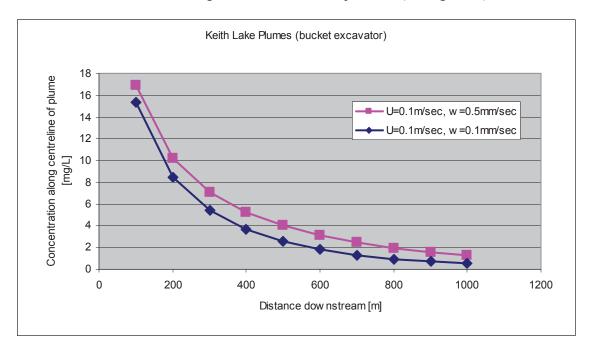
Figure 19 Concentration downstream of plume - Keith Lake

The Keith Lake dredging operation is expected to see significantly lower currents, also dredging rates are significantly lower for the Keith Lake work (approximately $1/10^{th}$ of the rates in Sabine Lake). Therefore dredge plumes are not expected to exceed 200m in width or length for the Keith Lake operations (see Figure 19)

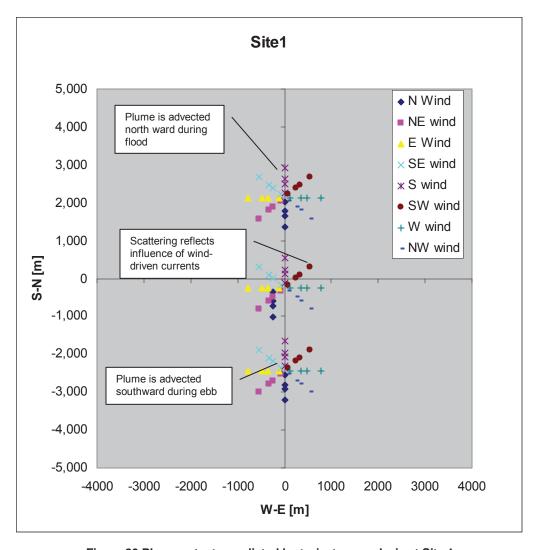
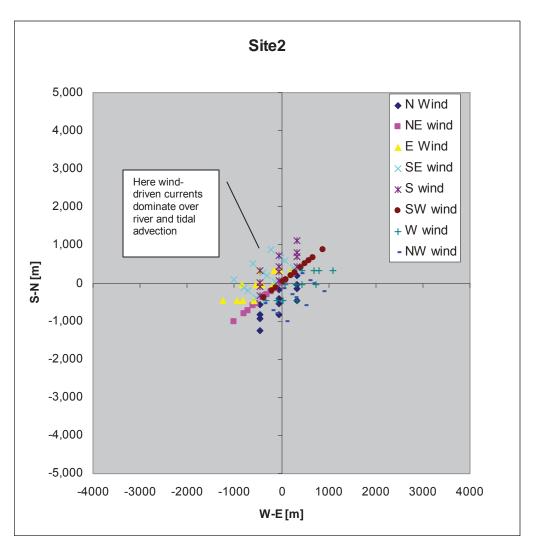
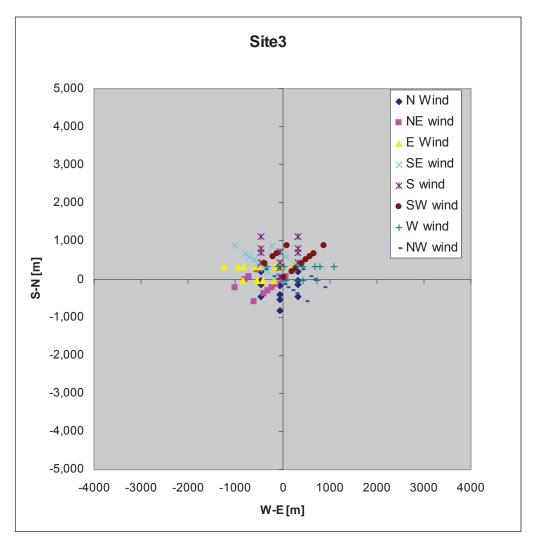
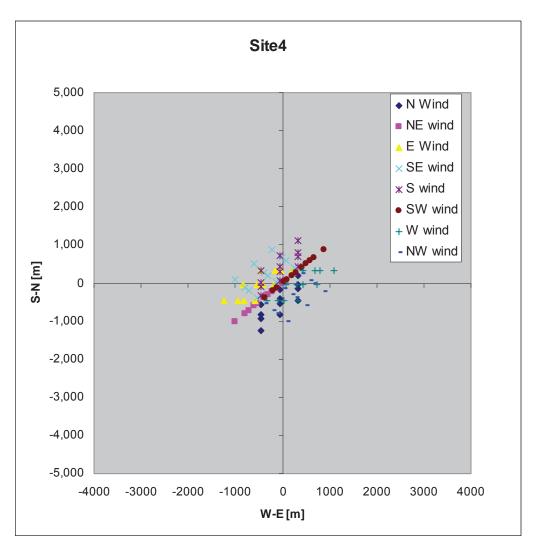
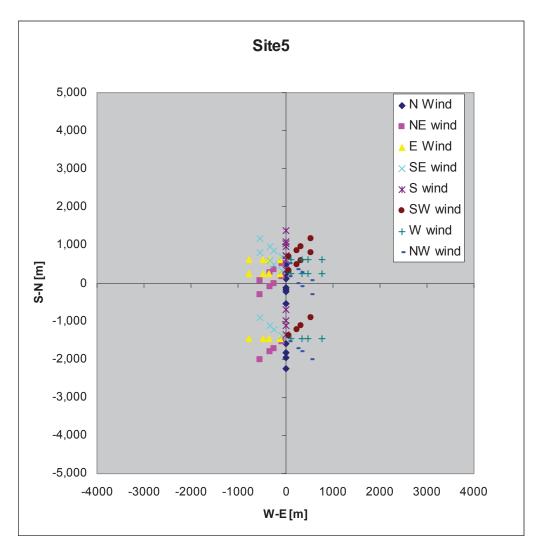
Plots of the range of sediment trajectories for each of the 5 study sites in Sabine Lake are presented in the following figures.

Figure 20 Plume extents predicted by trajectory analysis at Site 1

Figure 21 Plume extents predicted by trajectory analysis at Site 2

Figure 22 Plume extents predicted by trajectory analysis at Site 3

Figure 23 Plume extents predicted by trajectory analysis at Site 4

Figure 24 Plume extents predicted by trajectory analysis at Site 5

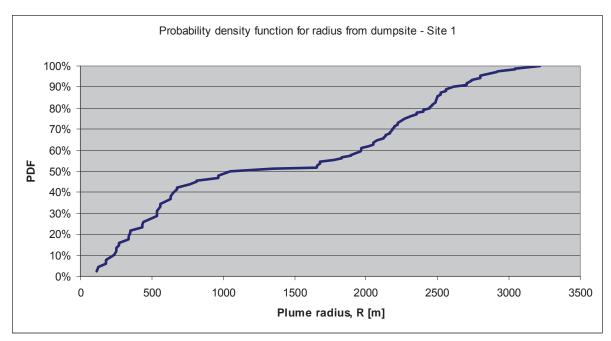
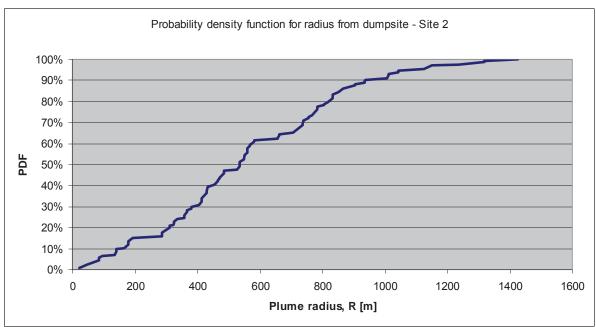
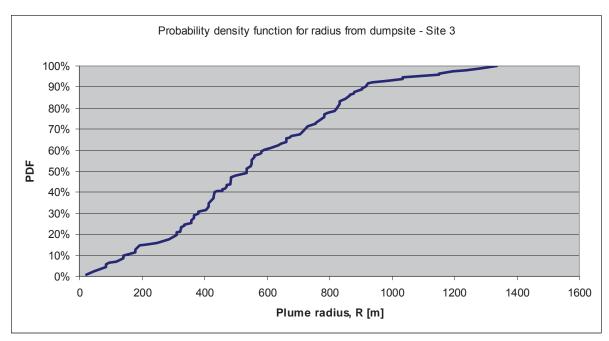
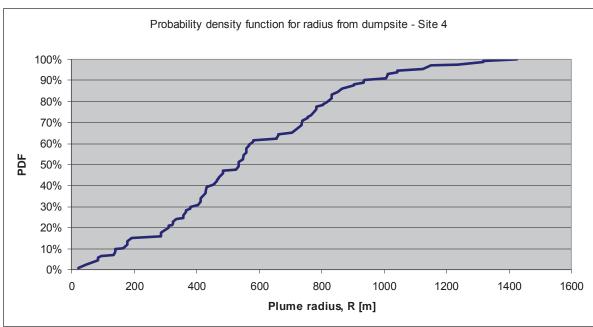
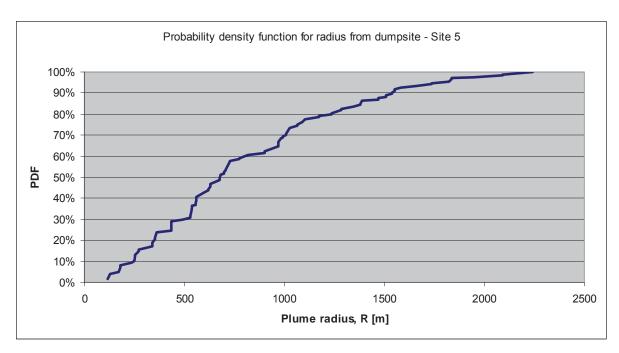
The overall frequency of occurrence for a given plume radius for each of the 5 study sites is presented in the following figures:

This trajectory-plume radius analysis indicates that turbidity plumes at the inlet and oulet of Sabine Lake could effect areas as large as 2-3km while in the center of the lake the plume-affected areas would be more typically about 1km wide.

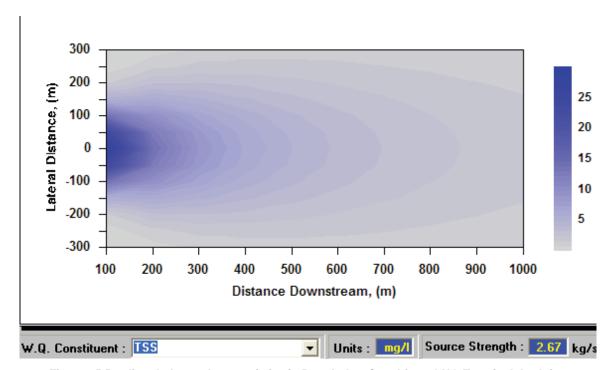
Figure 25 Predicted plume characteristics in Port Arthur Canal from LNG Terminal dredging

The quantity of material to be excavated at the LNG Terminal site far exceeds any excavation quantities for any of the pipelines. The use of a cutterhead suction dredge at this location along with properly designed and maintained dredged material dewatering operations should significantly reduce the rate of suspended sediment generation at this site. As mentioned in the foregoing, the loss rates for a large cutterhead suction dredge are expected to be of the order of 0.1% and a typical TGU of 5-10 kg/m³. At an average production rate of 16,000 yd³/day, it is estimated that about 3 kg/sec of sediment losses would occur. Using the DREDGE model, this would result in the following plume patterns for a 0.5mm/sec fall velocity in the Port Arthur Canal with an average flow velocity of 0.3m/sec and an average depth of 12m. Given that the average background TSS in the canal is of the order of 40 mg/L it is unlikely that dredging-related turbidity is likely to be a severe problem here. However, best dredging practices and close monitoring would still be advised.
